Your Home Inspection Report

Your New Home

File # 12,000
Inspection street 805 Center Street
City/State/Zip Lee, MA 01238
Client name Mickey Mouse
Street address 100 Main Street
City/State/Zip Orlando, FL
Home Phone
Cell phone 100-100-1000
Work phone
Email 1 MM@WDW.com
Email 2 JoeAgent@Flybynight.com
Email 3

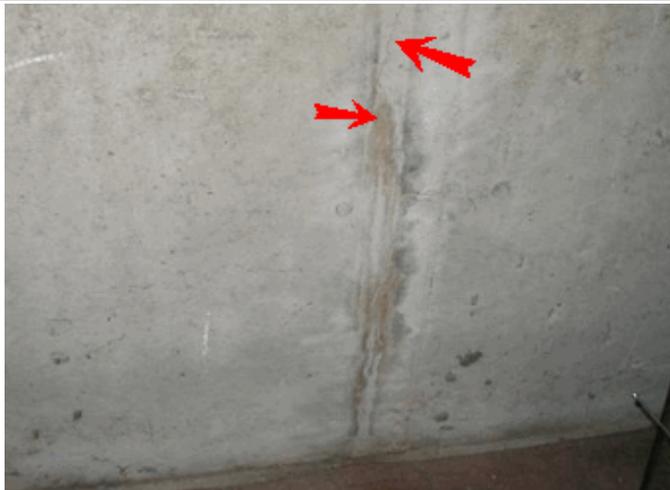
Crack in foundation wall is NOT a structural concern, some water weeps in

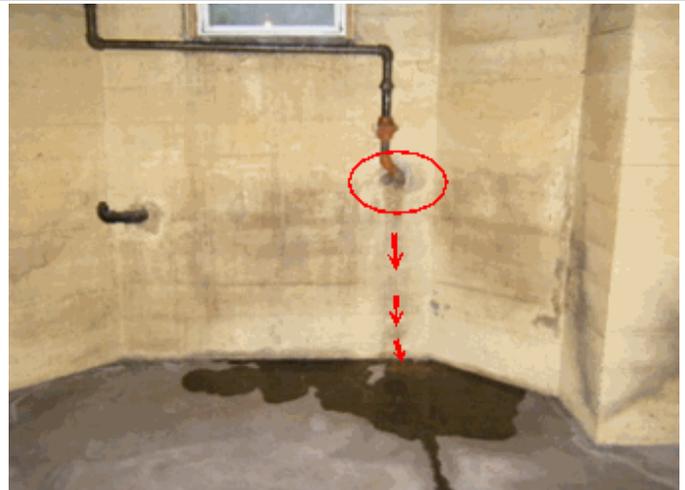
Water leaking into basement; seal around gas pipe & correct yard drainage to reduce

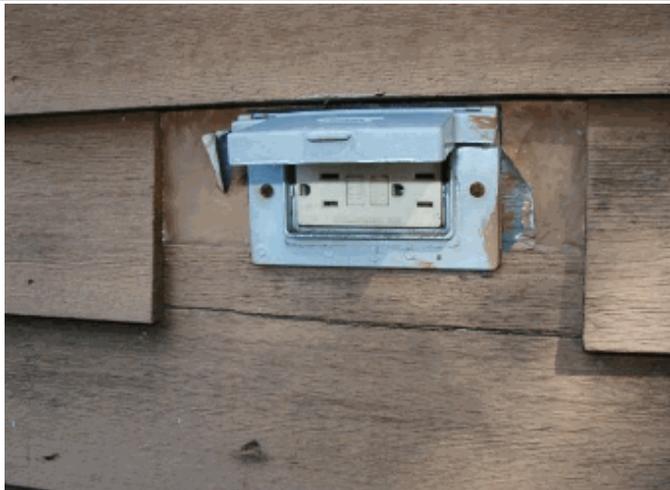
GFCI receptacle above deck does not trip off, and wood trim missing around cover

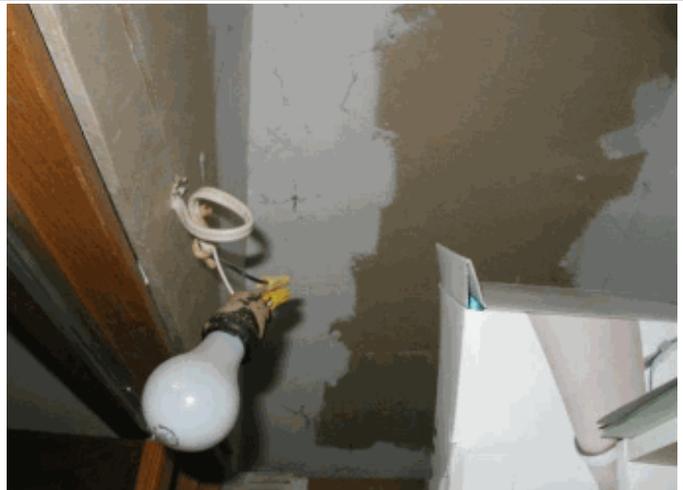
Bedroom closet has unsafe light, is a fire hazard, install pertinent fluorescent light

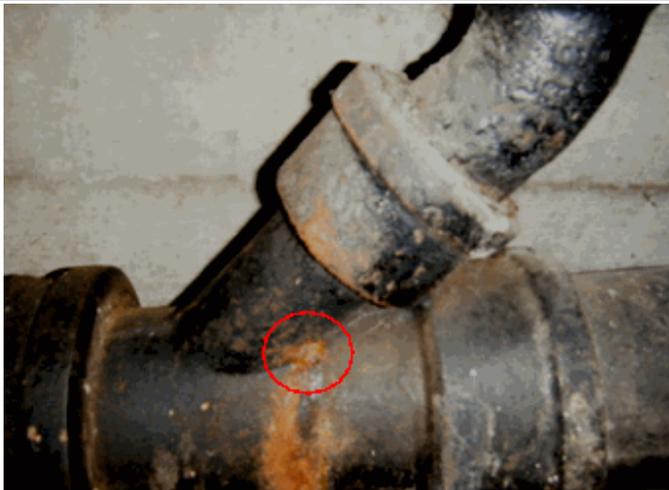
**Corrosion on drain pipe from pin hole leak;
replace drain pipe**

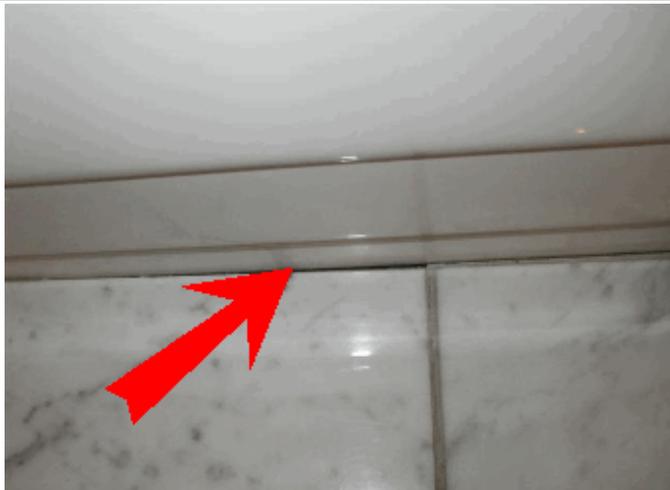
Seal between tiles and tub/showers

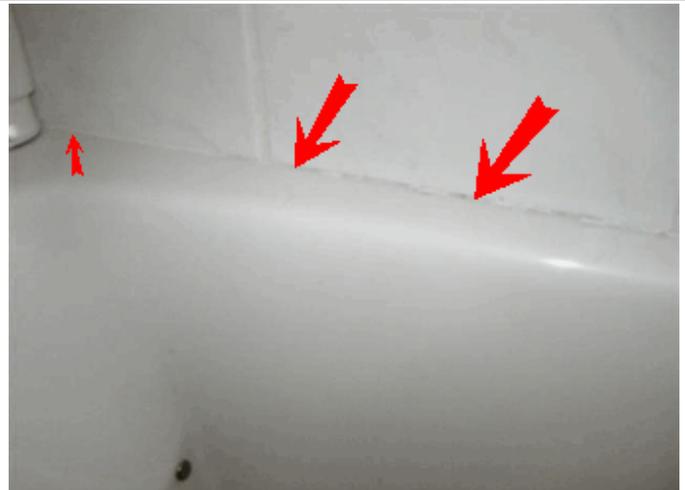
Seal between jet tub and walls

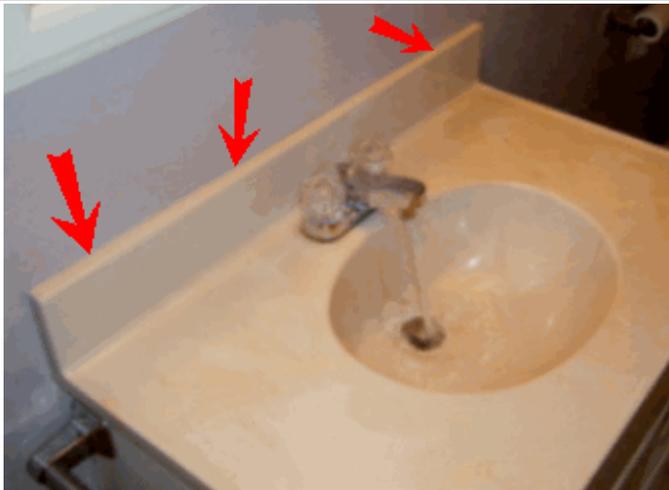
Seal between sink countertop and wall

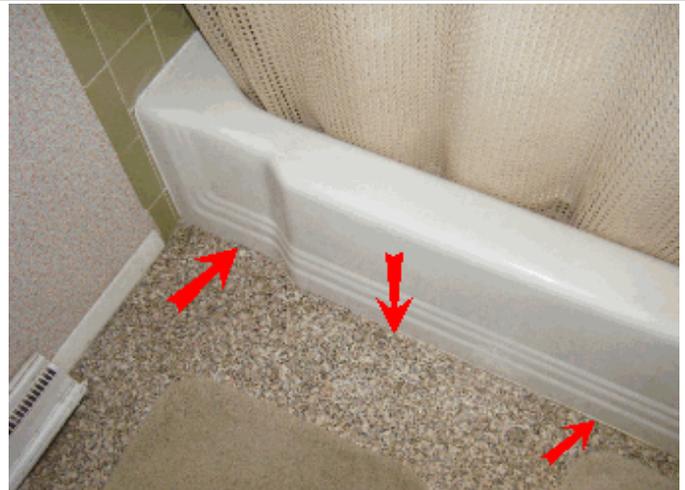
Seal between tub and floor to avoid floor damage.

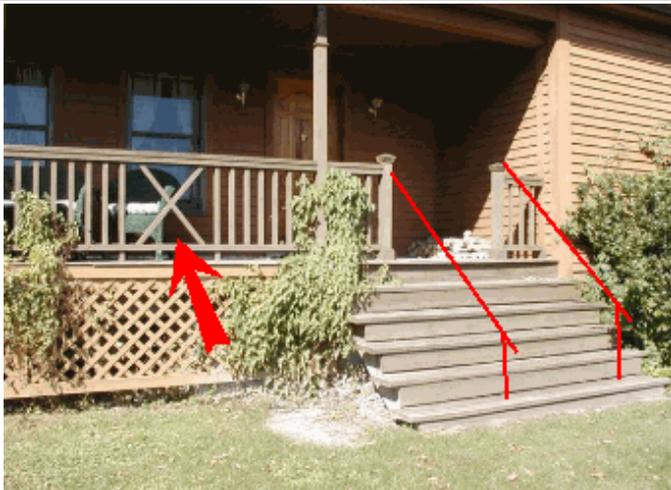
Add handrails along steps and openings below handrail too large in areas

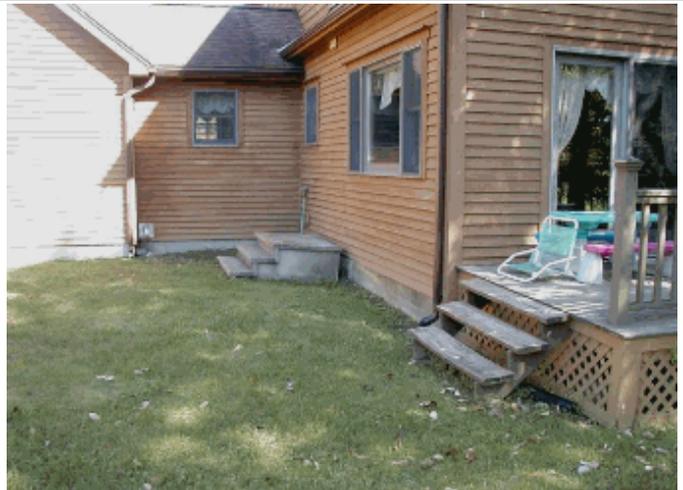
Remove concrete steps and correct yard drainage to shed water away

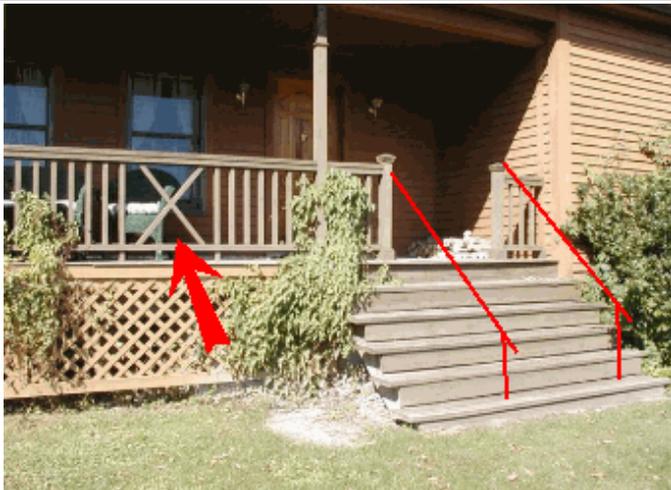
Add handrails along steps and openings below handrail too large in areas

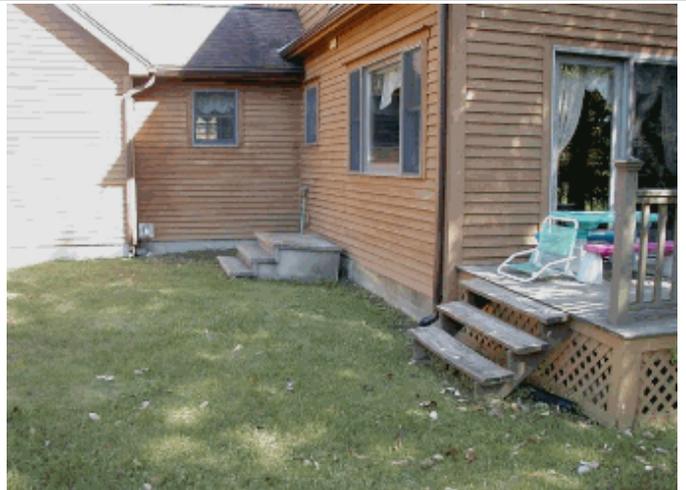
Remove concrete steps and correct yard drainage to shed water away

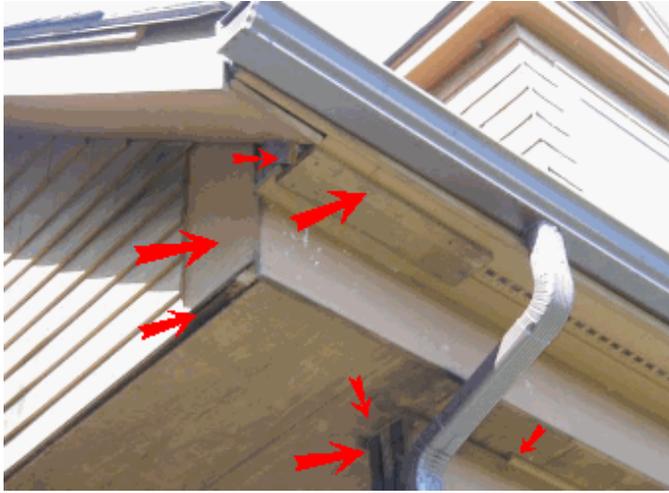
Exterior: Missing molding outside

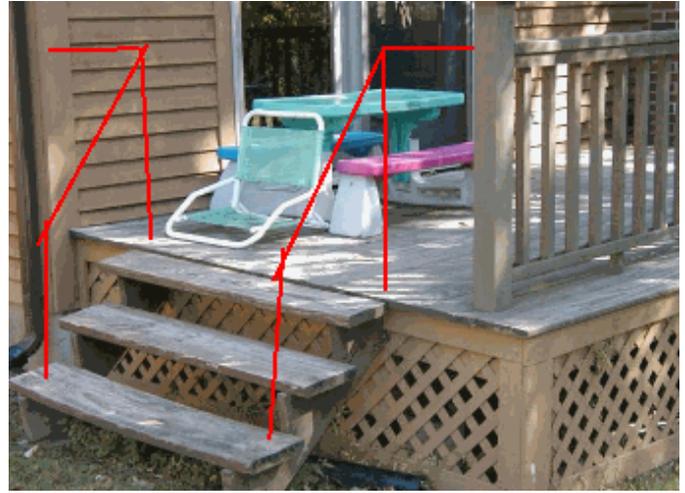
Exterior: Replace back deck steps and extend handrails for SAFETY

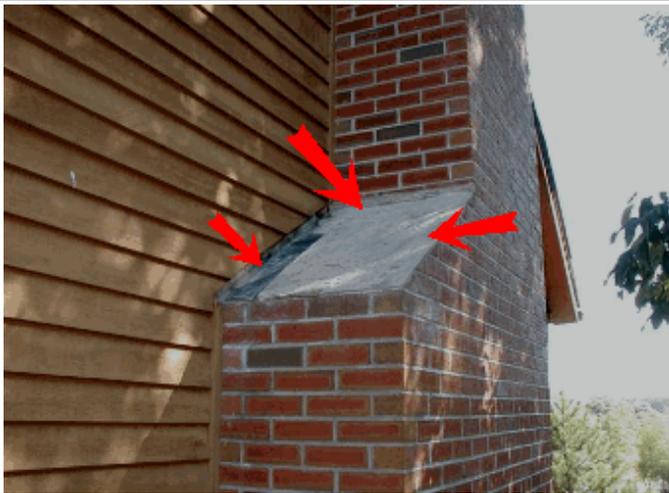
Exterior: Flag stone missing from chimney

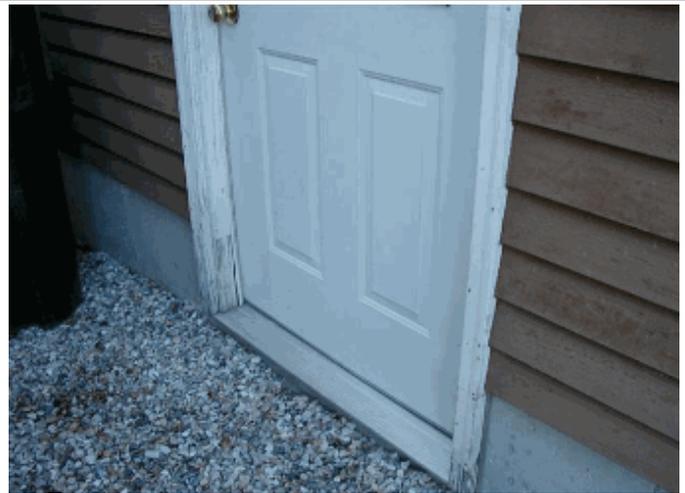
Exterior: Paint trim on garage door to avoid wood rot

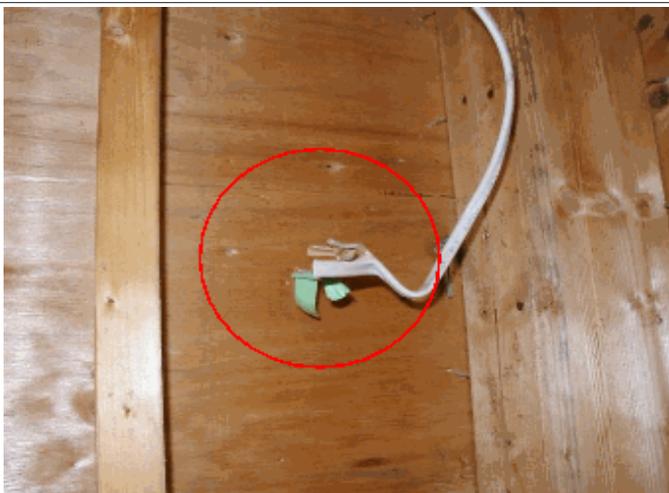
Elect.: Terminate free end wires in boxes, this one in garage one under window in bedr
