Your Home Inspection Report

Your New Home

File # 12,000
Inspection street 805 Center Street
City/State/Zip Lee, MA 01238
Client name Mickey Mouse
Street address 100 Main Street
City/State/Zip Orlando, FL
Home Phone
Cell phone 100-100-1000
Work phone
Email 1 MM@WDW.com
Email 2 JoeAgent@Flybynight.com
Email 3

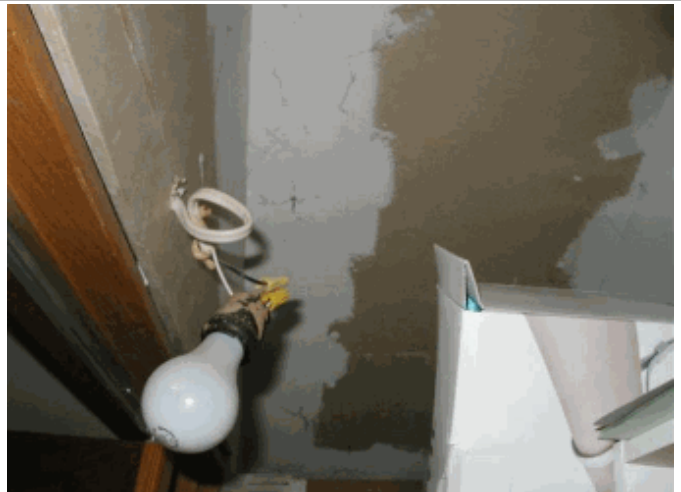
Bedroom closet has unsafe light, is a fire hazard, install pertinent fluorescent light

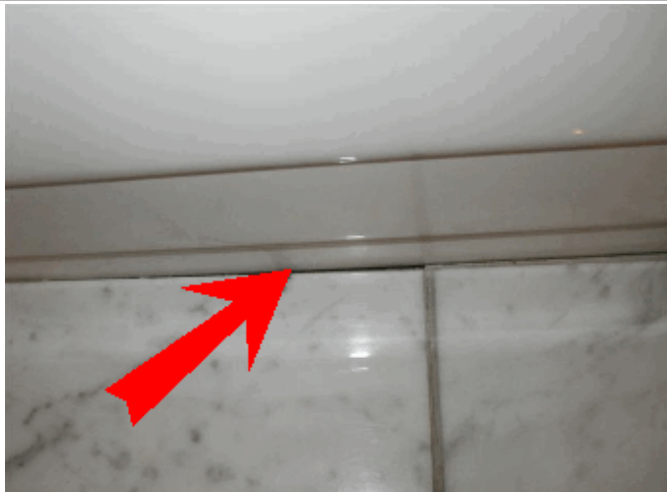
Seal between tiles and tub/showers

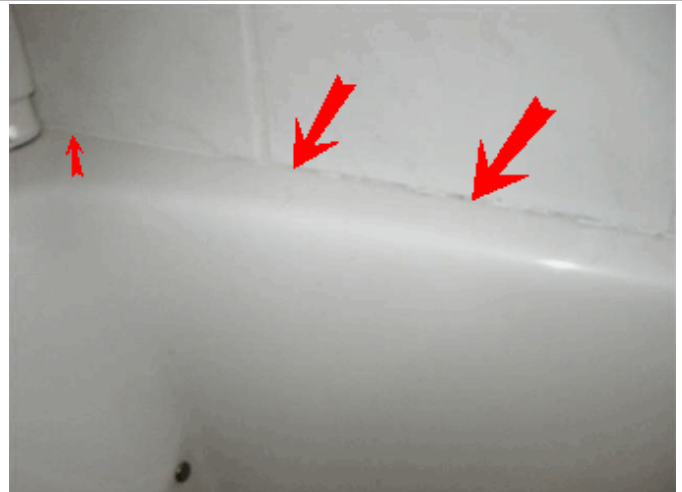
Seal between jet tub and walls

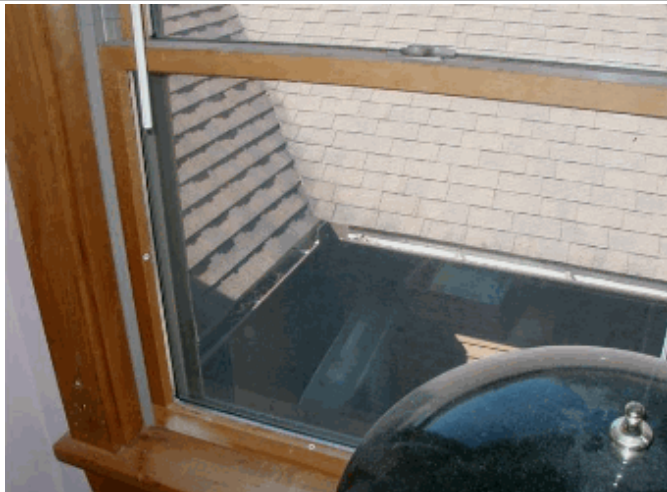
Glass is fogged, replace glass to make clear

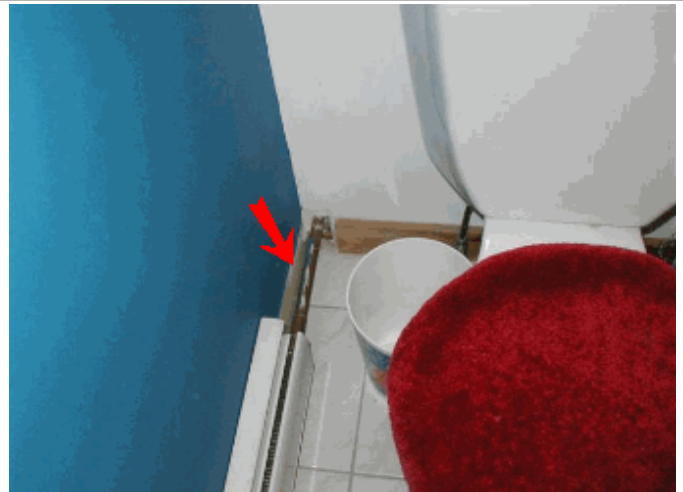
Trim missing in many areas and radiator cover missing too

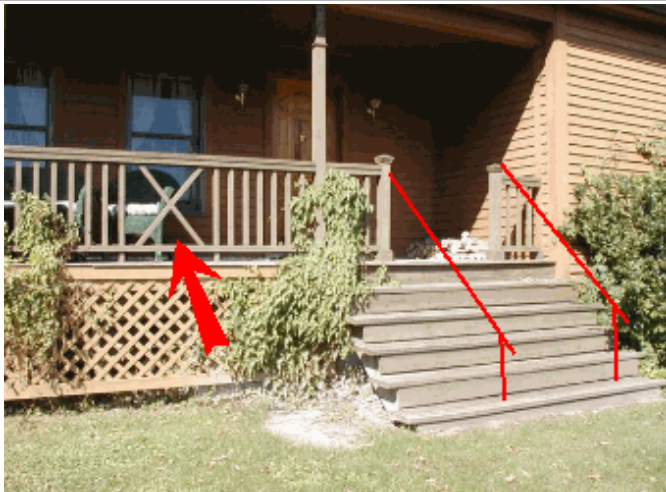
I: Openings are too large below deck/stair handrails; correct for child SAFETY. Stain deck.

**Add handrails along steps and openings
below handrail too large in areas**

L: Replace back steps to deck. Add handrails along both steps. Secure loose posts at the top of the front steps.

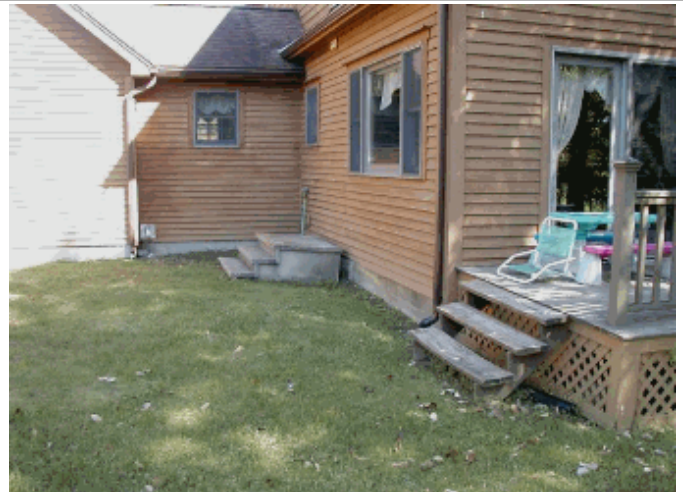
**Remove concrete steps and correct yard
drainage to shed water away**

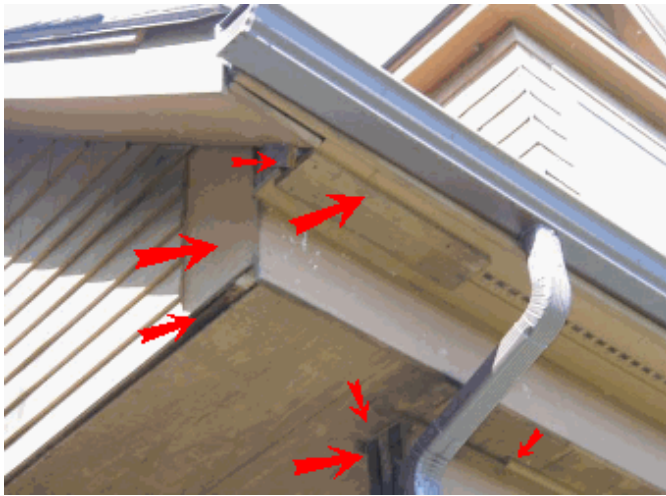
Exterior: Missing molding outside

N: Trim missing in a number of areas as we pointed out. Paint trim/frame of garage side door to avoid more wood rot, repair/replace the small area of wood rot near the bottom of the door frame.

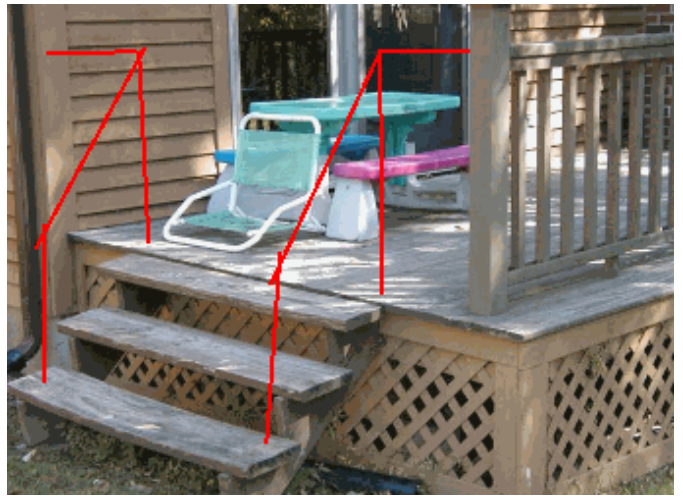
Exterior: Replace back deck steps and extend handrails for SAFETY

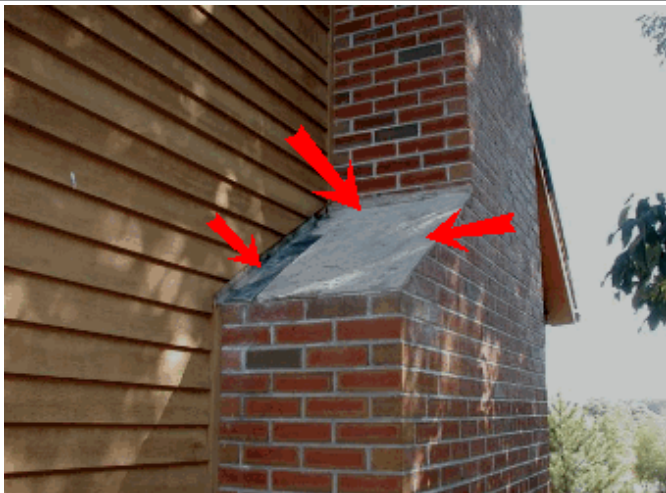
Exterior: Flag stone missing from chimney

C: Reinstall a flag stone on the side of the chimney as we discussed.

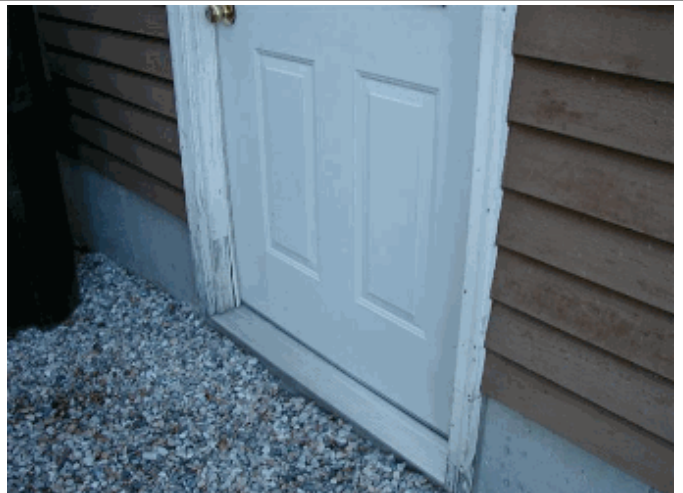
Exterior: Paint trim on garage door to avoid wood rot

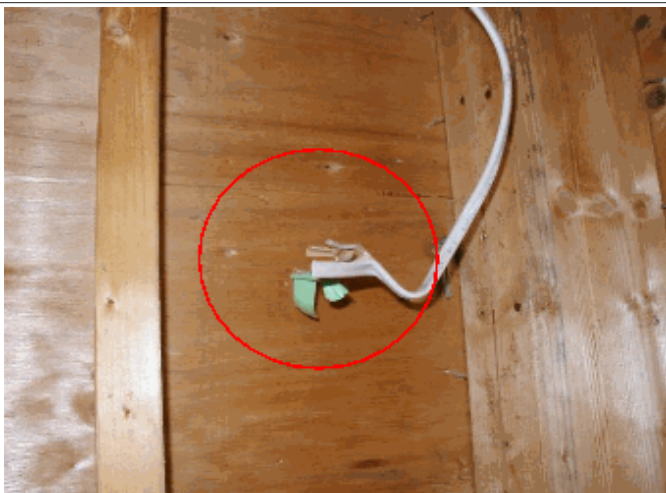
Elect.: Terminate free end wires in boxes, this one in garage & one in master bedroom
