Infrared Camera by Finn Home Inspectors

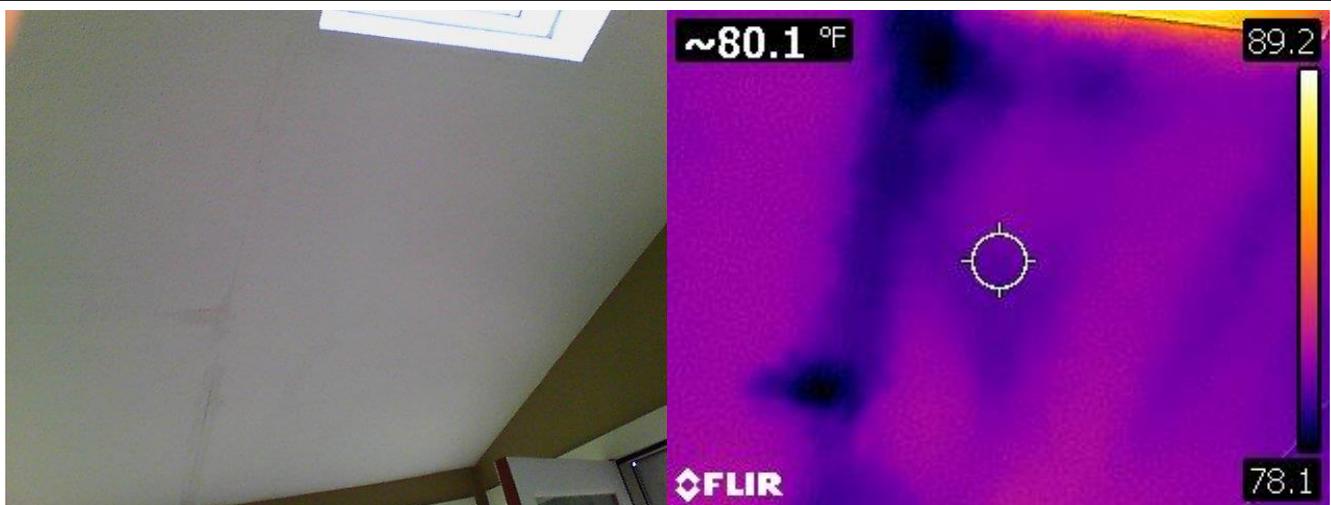
Above – Ceiling below skylight has water stains, the skylight flashing had been repaired, But did the repair work? The IR scan may be able to determine the repair did not work if there had been recent weather conditions creating water entry. The IR scan could NOT say that the repair was adequate.

Above – IR photo below the skylight shown in the photo to the left. The dark stains indicated likely water leakage, a moisture meter was used and verified moisture present. So in this one the inspector was able to tell the buyer that the roof repair for the skylight flashing did not correct the leakage.

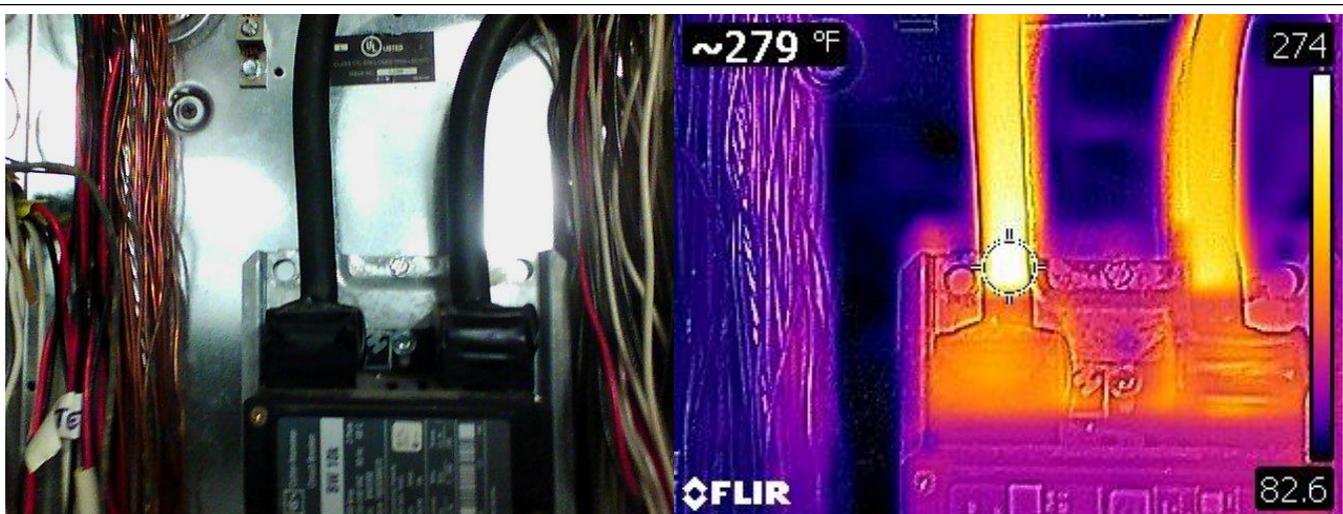
Above – The black cables were the main power feeds into the electric panel main breaker. Visually there was no apparent problem, however see IR photo to the right.

Above – IR photo indicates one of the power entry cables into the main breaker is overheating, temperature of 279 Degrees F, which is a fire Hazard! Follow up, by an electrician, determined it was due to a loose lug connection at the main breaker.
