# Kicker Roof Flashing by Finn Home Inspectors

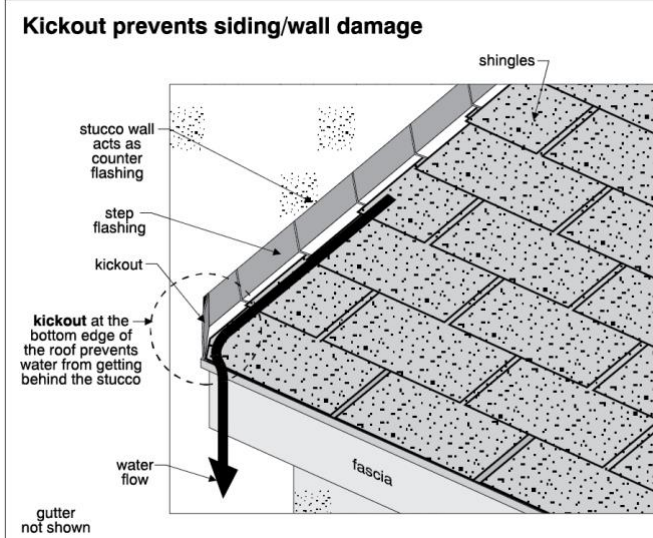
Kicker that is integrated into the step flashing.

A roof flashing kicker diverts the water at the bottom edge of a roof away from an adjacent wall, see diagram below. Without the kicker water may run off the roof and down the adjacent wall siding causing fungus growth and deterioration of the wall.

When initially installing roof shingles the kicker is made in the last piece of step flashing at the lower edge of the roof as shown in the sketch below. In a retro fit often the kicker may be attached to the top of the roof shingles, see photo below.

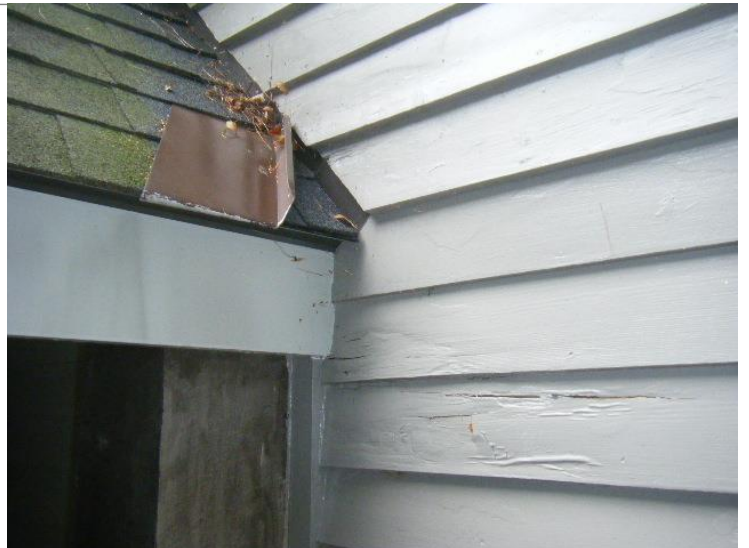
Kicker installed after damage was done to adjacent wall, note deterioration in siding. Kickers added after often are smaller than shown but just as effective.

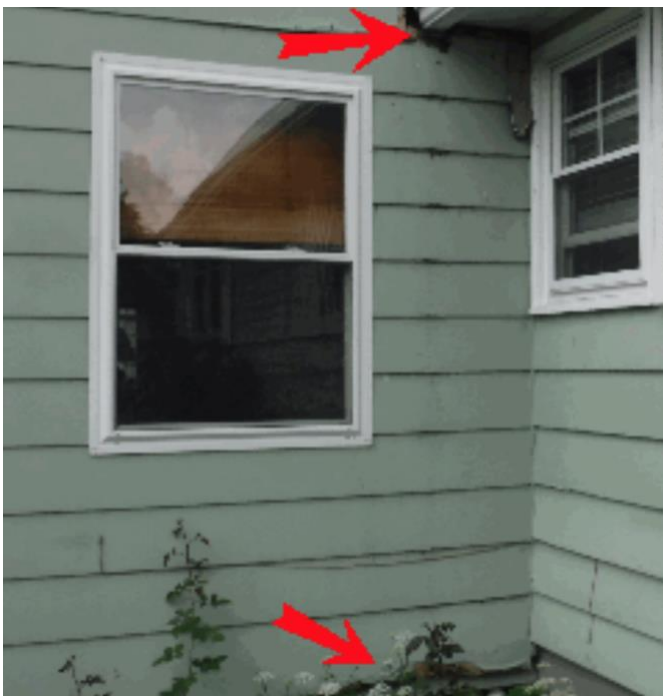
No kicker on upper roof, water has run down siding has stained it and deteriorated the siding. We often see window frames damaged too.

As you can see in the photos below water running down the side of the house can cause much damage to the wall, and if a window or door is present can do much damage to them also.

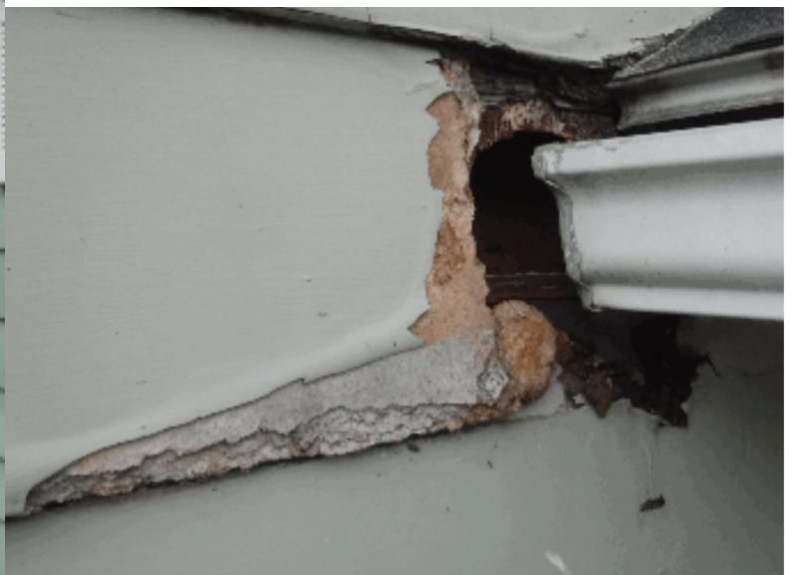
With no kicker the water has rotted through the siding and likely has damaged the framing for the wall behind the siding.
