Proper Attic Venting by Finn Home Inspectors

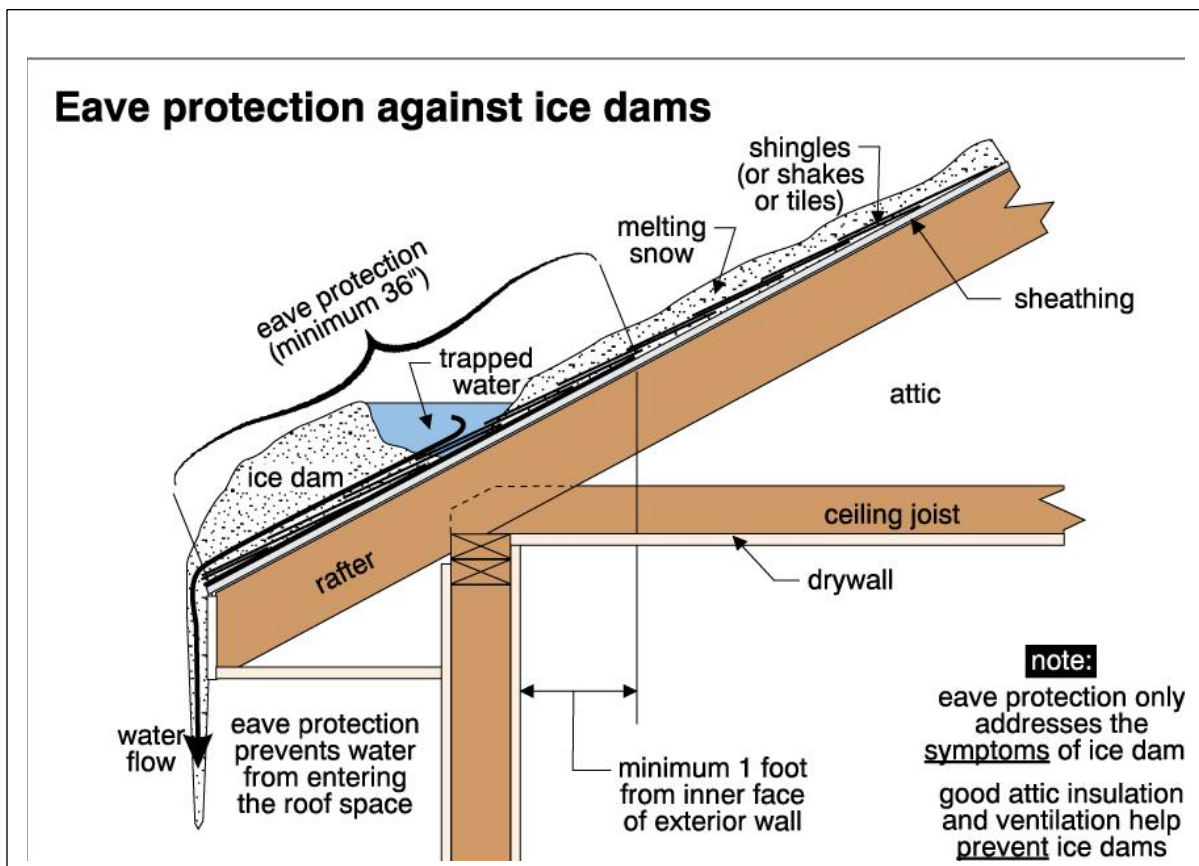
The first figure is artwork showing a cross-section showing an ice dam at the bottom of the roof. A proper roofing contractor will install a membrane below the shingles up 36+ inches to avoid leakage, as shown in the diagram (often called "ice & water shield"). (art from Carson/Dunlop).

Proper attic venting is critical to avoid mold growth, moisture problems and roof ice dam induced water leakage. Ideally the attic temperature will be the same as outside, thus snow will not melt on the roof. If snow melts on the roof it may flow down and create an ice dam at the bottom of the roof, possibly causing a water leak.

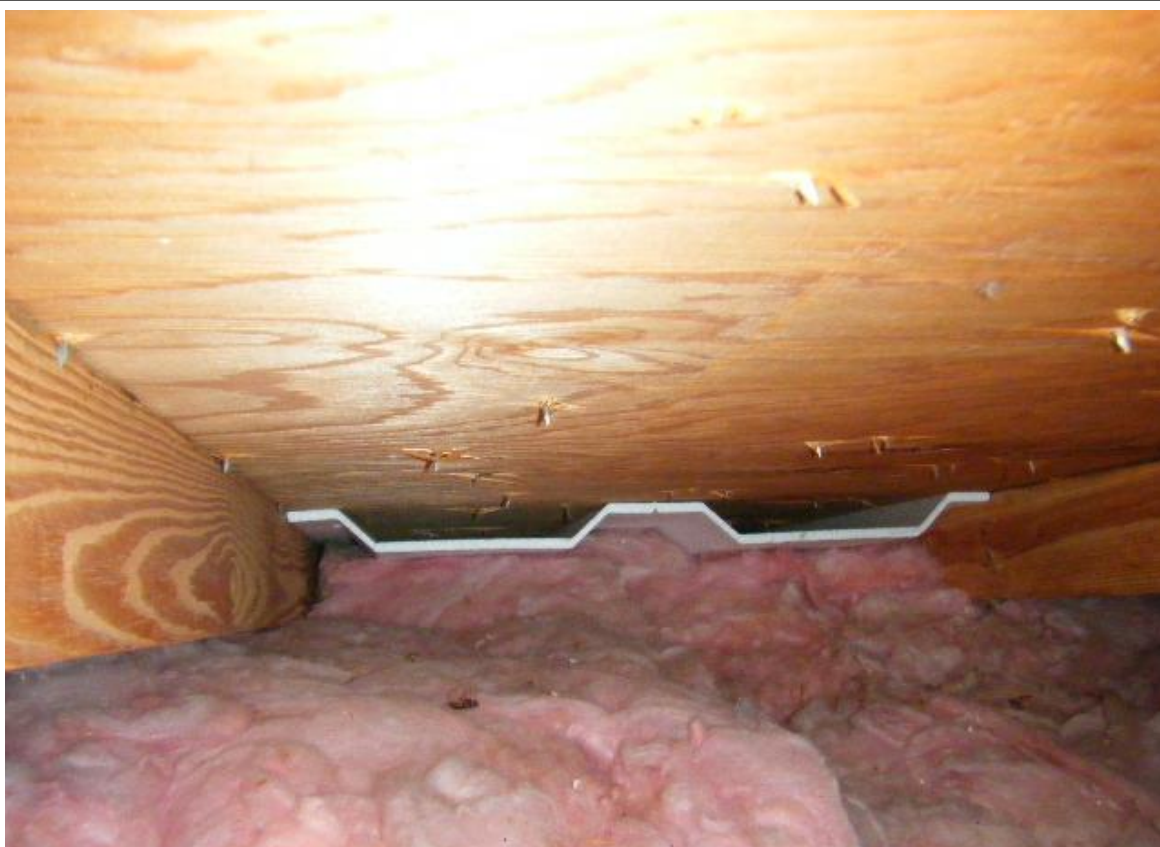
The photograph, taken from the attic, shows a proper vent installed.

To allow air flow from the soffit area and to allow the maximum insulation over the outside wall, proper vents are used. They are installed against the roof sheathing (the wood that shingles are nailed to) and provide an air gap just under the sheathing for air flow.

When loose insulation is blown in, the proper vent is typically run much higher along the roof sheathing to avoid insulation being blown into and blocking the vent during installation.
