Wood "I" Beams by Finn Home Inspectors

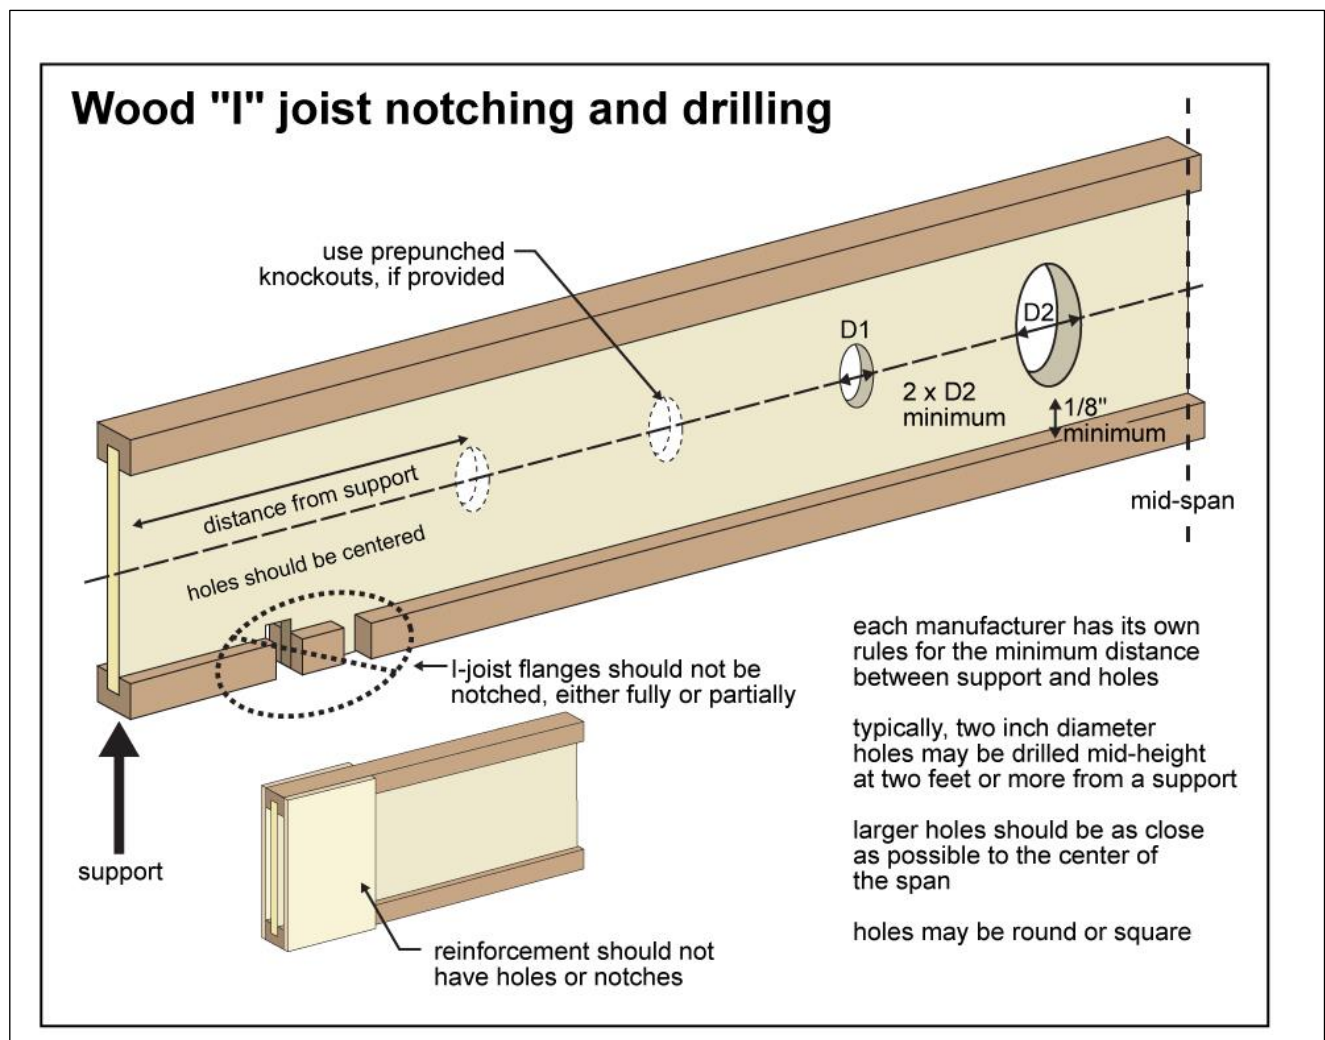
Top diagram from Carson/Dunlop.

Some notches and holes are allowed, see diagrams below. Note: depending on type of joist determines what is allowed and what is not.

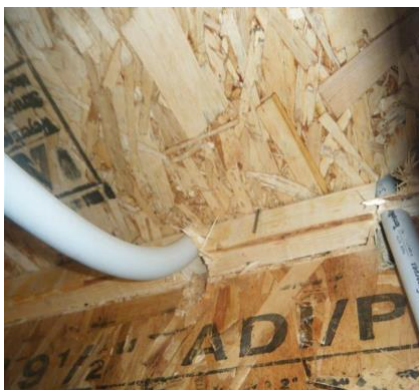
Wood I beam- Top flange cut, must be repaired, Repair design by Engineer.

Wood "I" joists cannot have any cuts, notches or damage in their top or bottom flanges. Actually, they may need additional reinforcing if there is a load bearing above, such as a wall.

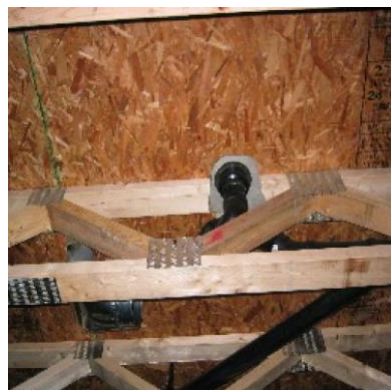
Wood Floor Truss- Top cord cut through, Need Engineer to design repair.
