# Skylight Leakage by Finn Home Inspectors

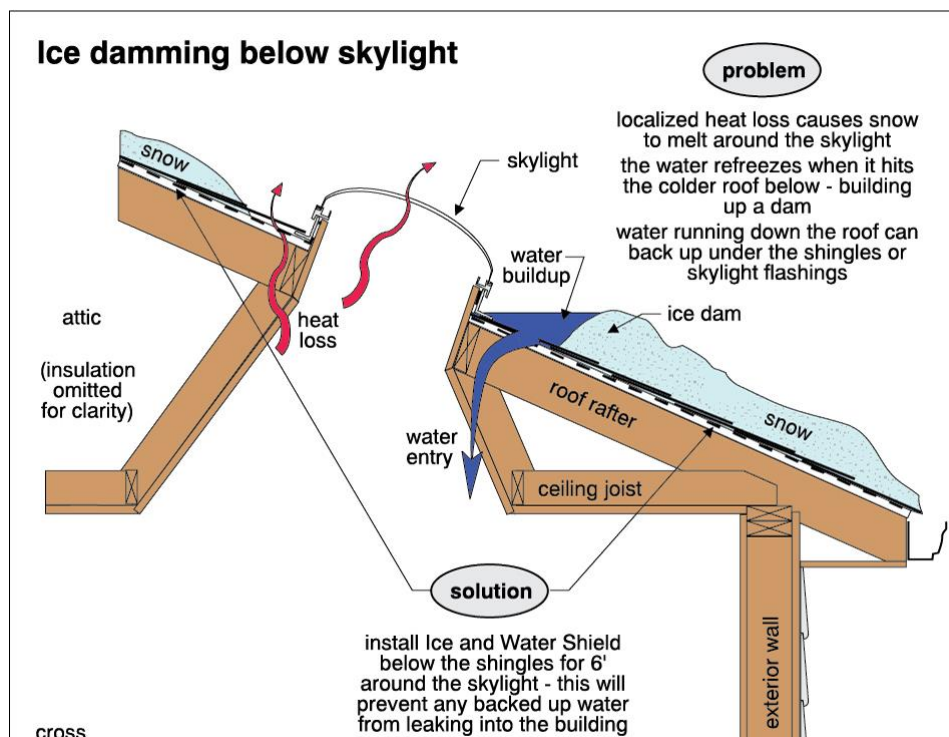
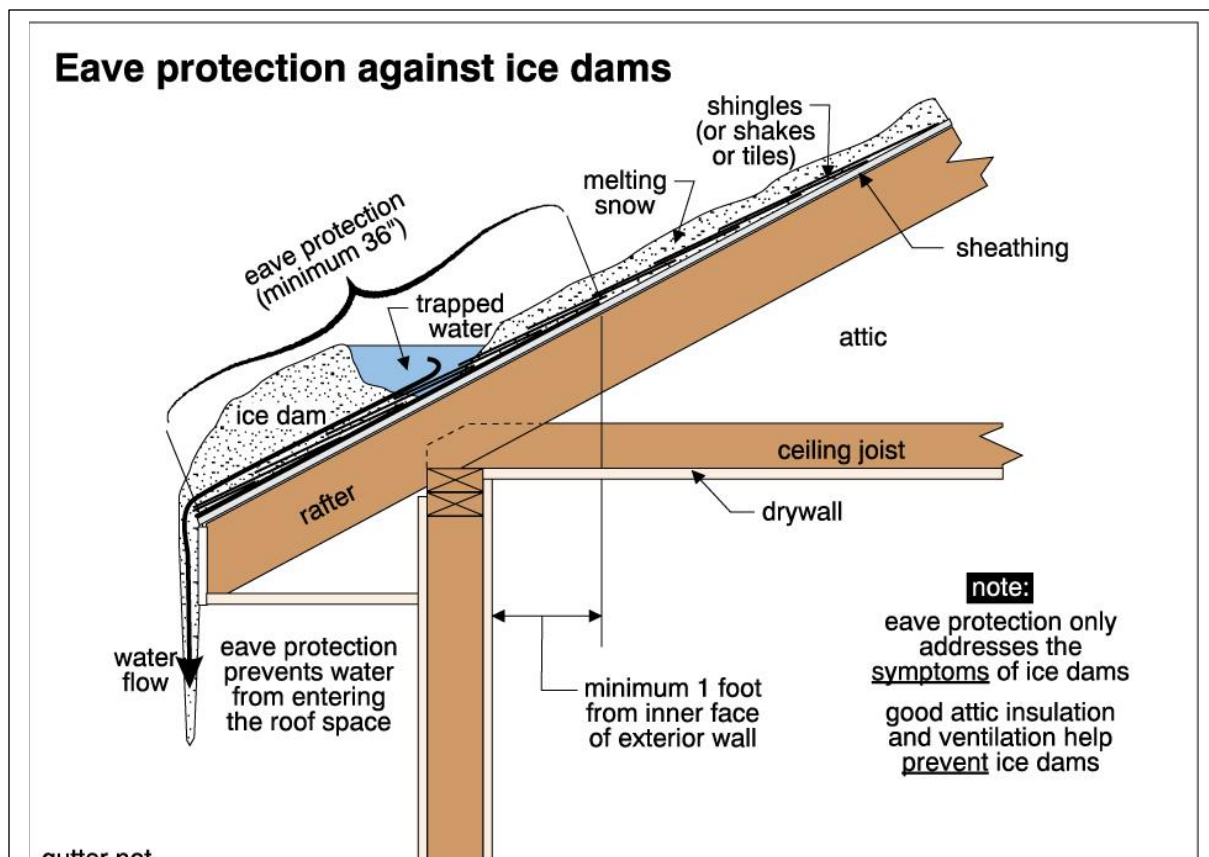
Below are diagrams showing how insulation and air flow should be in a house, (Art from Carson/Dunlop)

Surprisingly it does not have to be raining to leak, see diagram below, in norther climates poor venting and insulation around/below a skylight can create an ice dam induced leak which typically would be at the lower edge of a roof.
