# Notched Joists By Finn Home Inspections

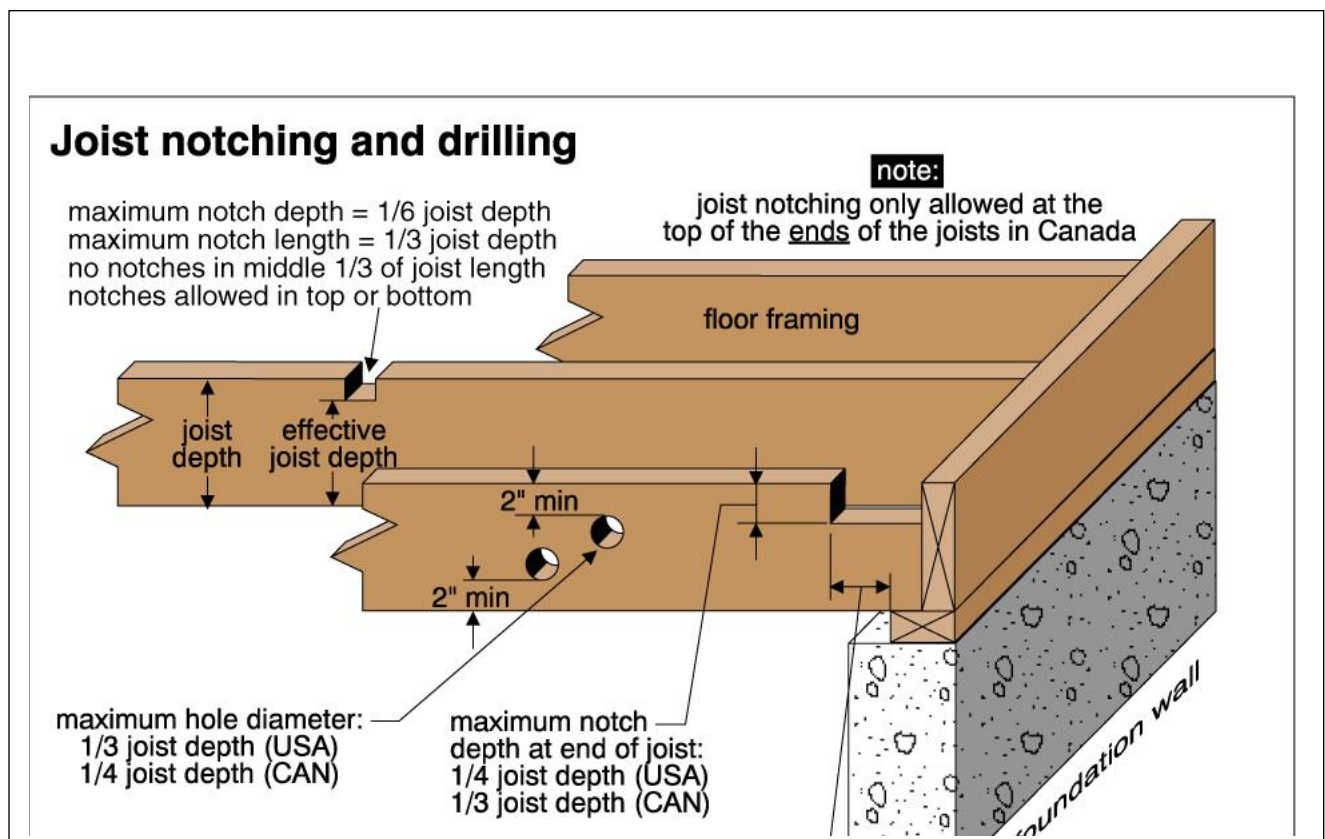
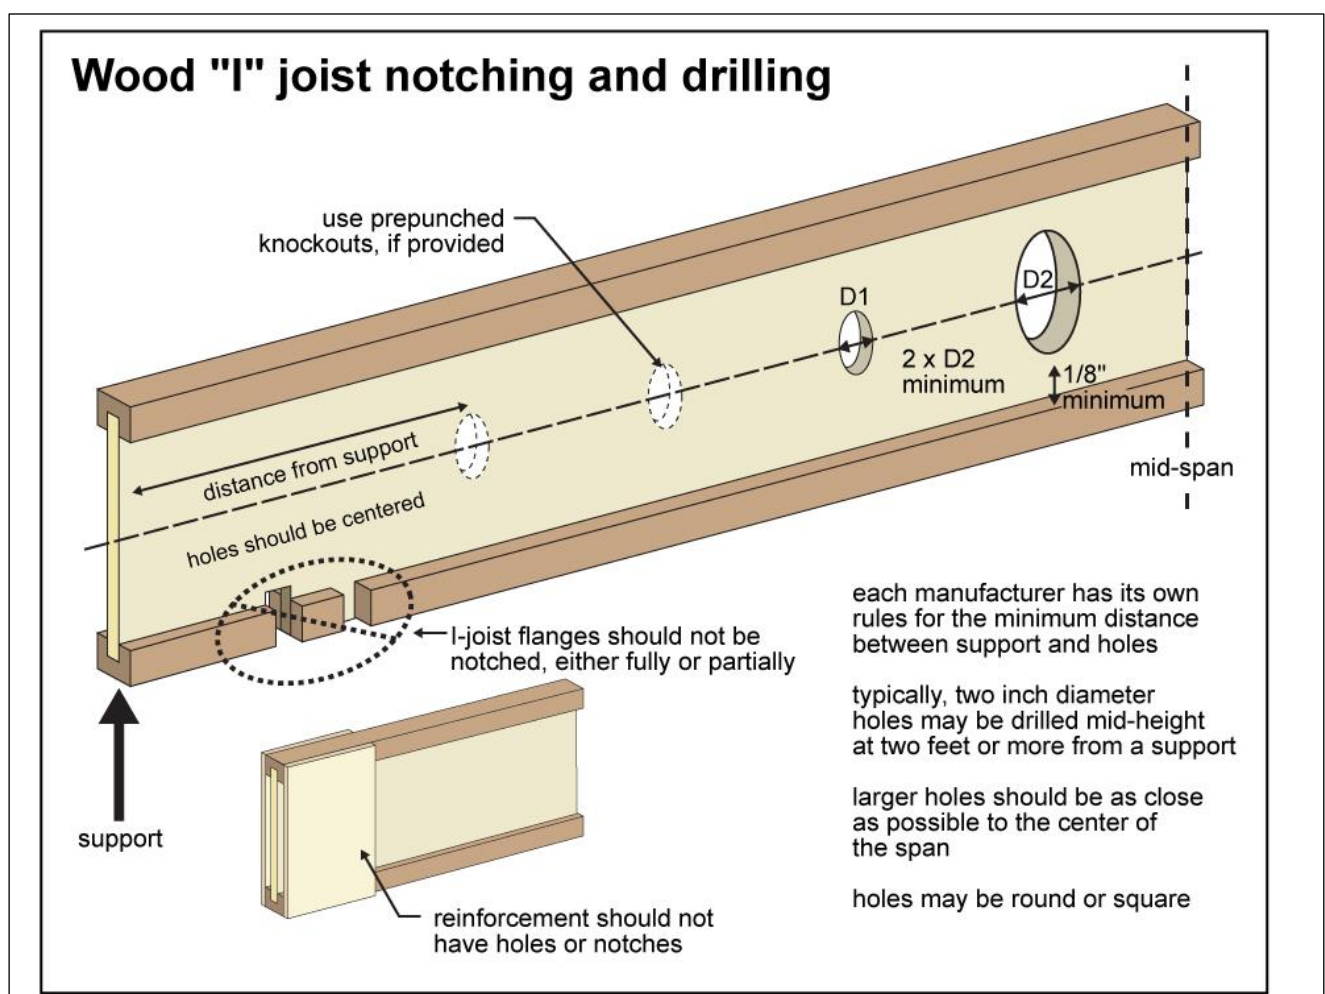
Some notches and holes are allowed, see diagrams below. Note depending on type of joist depends on what is allowed and what is not.

Diagrams from Carson/Dunlop.

Notches, cuts and holes in joists, beams or rafters can severely reduce their strength and can lead to failure/collapse in the worst cases. The main beam should have no holes or notches.

Wood "I" joists cannot have any cuts, notches or damage in their top or bottom flanges. They may need additional reinforcing if there is a load bearing above, such as a wall.
